Combustion Device Failures During Space Shuttle Main Engine Development

Otto K. Goetz
NASA

**5th International Symposium on Liquid Space Propulsion
Long Life Combustion Devices Technology**

Chattanooga, Tennessee
October 27-30, 2003

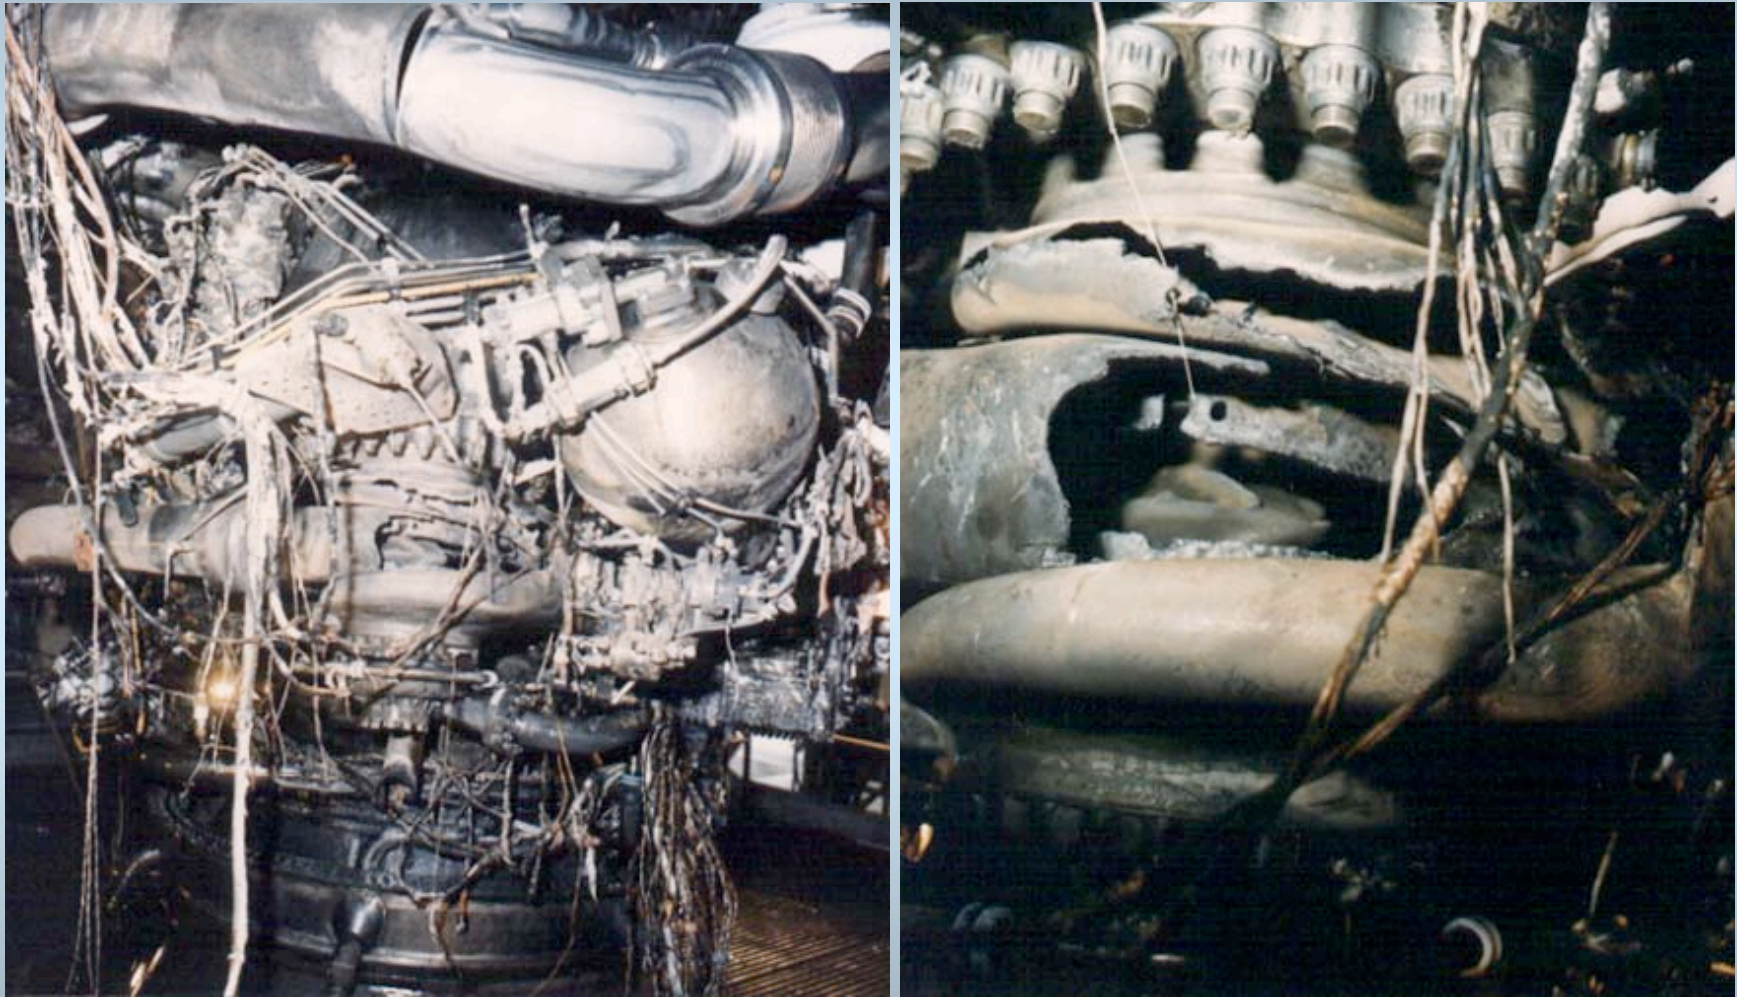
Test 901284, Engine S/N 0010

An erroneously high reading combustion chamber pressure caused the Controller to close the Oxidizer Preburner Oxidizer Valve to reduce Pc to the desired value. A few milliseconds later, the Controller calculated a mixture ratio of 9.0 and commanded the Fuel Preburner Oxidizer Valve full open in an attempt to reduce the MR to 6.0. The immediate result of the Controller actions, based on an erroneous Pc, was operation in an abnormal mode, characterized by high fuel flow and low turbine temperature. The HPOTP turbine inlet temperature fell below a value which led to freezing of water in the turbine gases. The ultimate result of the Controller actions was a fire in the HPOTP at about 9.7 seconds due to rubbing in the area of the Lox primary seal. The rubbing was caused by a high axial load which displaced the rotor assembly toward the pump end of the HPOTP housing.

Cause: Two unrelated events caused this failure to prorogate to a catastrophic failure. First, Channel B of the Engine Controller cut itself off at 3.25 seconds because of failure of electronic components in the facility power supply. Secondly, at 3.9 seconds, the Lee Jet orifice, used to purge the Channel A Pc transducer passage, became dislodged and caused the Pc transducer to sense MCC coolant flow pressure instead of Pc. The reason for the Lee Jet orifice dislodging was a poorly machined Lee Jet housing that went undetected. It was out of specification and should have been noted.

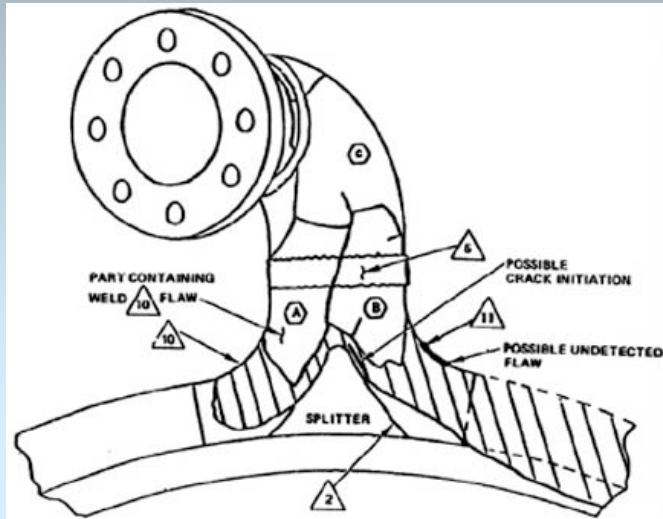
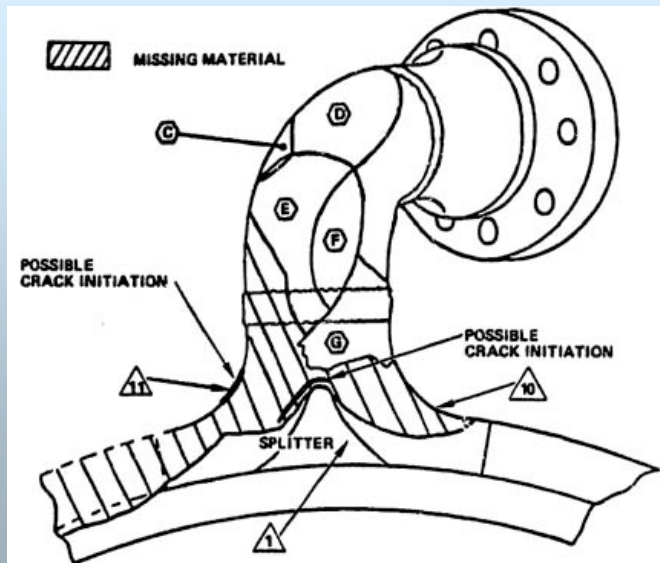
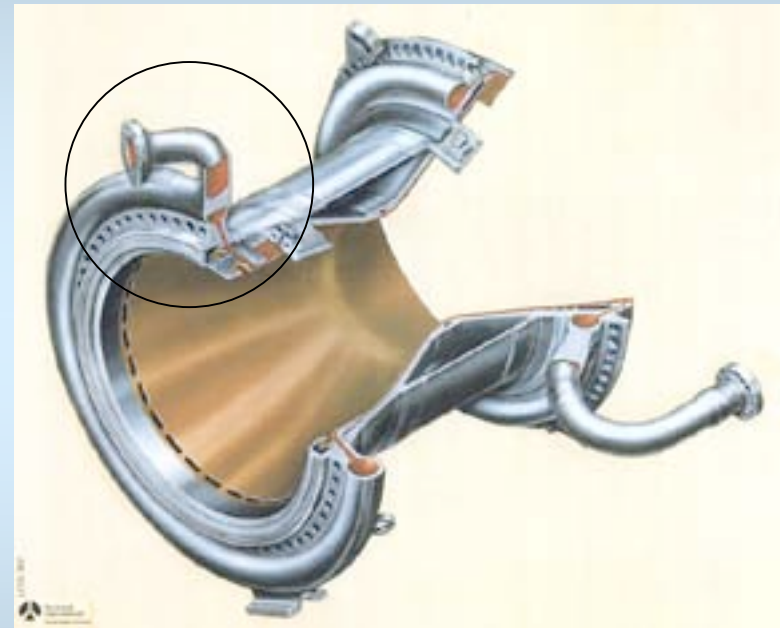
Test 7502594, Engine S/N 2308

Catastrophic failure of Engine 2308 was caused by rupture of the MCC outlet manifold neck which resulted from an initial fatigue crack that grew to instability. In response to the rupture, the low-pressure fuel turbopump rapidly decayed in speed, further indicating the source of the leak to be in the MCC outlet system. The speed drop rapidly reduced discharge pressure (inlet pressure to the high-pressure pump) and the high-pressure fuel pump went into deep cavitation. As a result of deep cavitation, the high-pressure fuel pump speed increased to a value 30% over FPL nominal, rapidly increased pump vibration which exceeded the vibration redline, and led to a cutoff command. Following cutoff, the fuel cavitation condition resulted in reduce engine fuel flow and a severe oxygen-rich condition. Burnout of the turbines, burn-through of the hot-gas manifold and severe erosion of the gimbal bearing produced conditions leading to separation of the engine below the low-pressure pumps.

Cause: The precise origin and initiation mechanism for the failure was not established. Fatigue or an undetected defect were both postulated as potential failure modes for welds No. 1, 2, or 11 of the MCC outlet neck. The most probable cause of failure was determined to be fatigue (endurance) crack initiation at splitter welds No. 1 or 2.
